CASE STUDY | HTN

Nuclear Power Plant: Steam Turbine Inner Casing Closure

HYDRAULIC TENSIONING NUT (HTN)

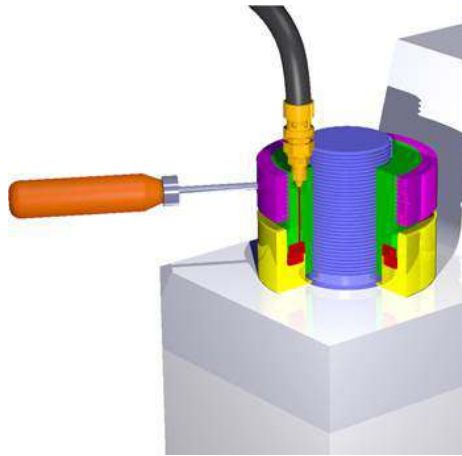
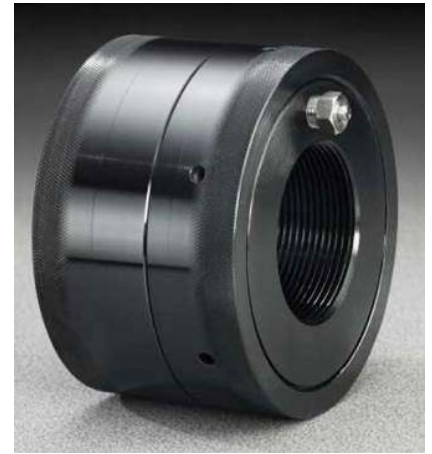
- Greater loads within restricted footprints
- Shortened turnaround times
- Easy adaptation for retrofitting to studs not extending above nuts

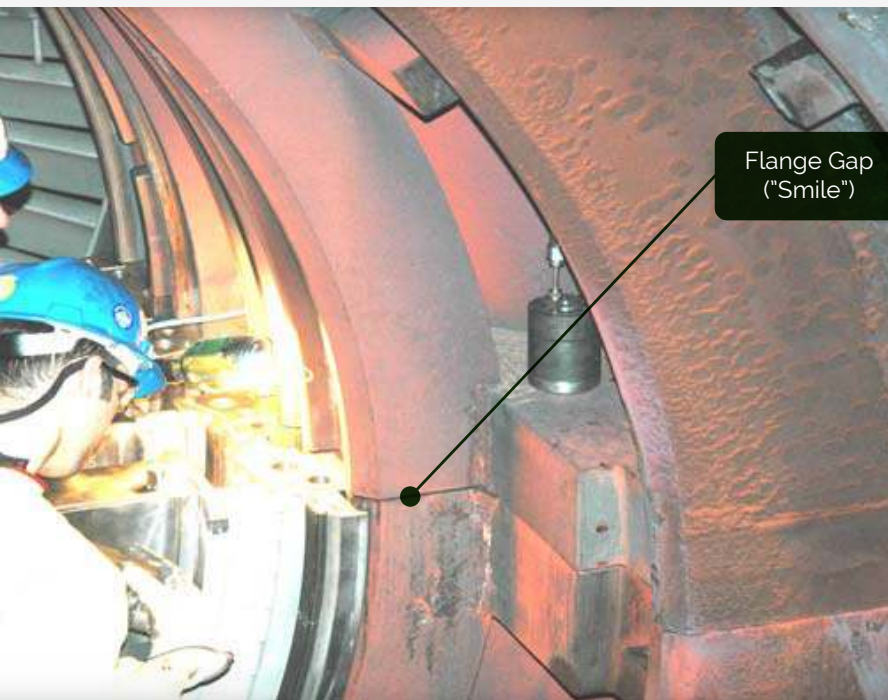
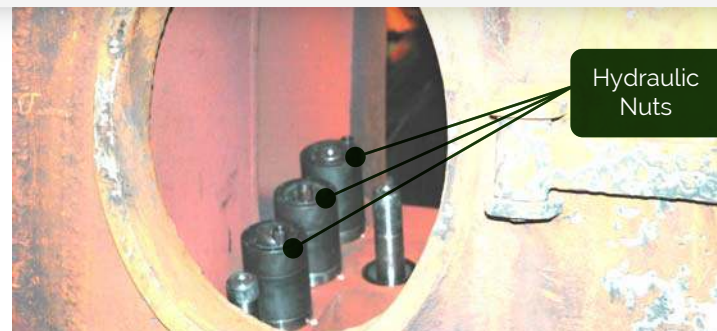
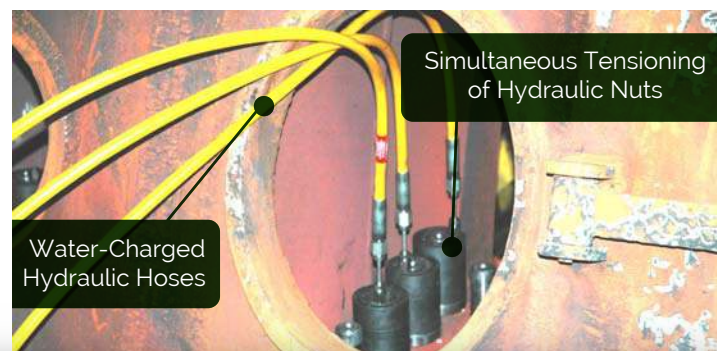
1. Simultaneous tensioning of studs provided precise loading allowing full flange closure
2. Developed sufficient clamping to overcome warping of inner casing
3. Labor hours drastically reduced – turnaround reduced by one month
4. Water-charged hydraulic nuts eliminated contamination concerns

1. Insufficient loading using conventional torquing methods caused warped flanges
2. Leakage between stages due to gap between flanges (known as "smile")
3. Labor-intensive operations led to over-budgeted turnarounds
4. Contaminants in the steam path
